# Shoreline Movement Study, Point Peron Rockingham

Department of Transport  
New Coastal Assets Directorate  
Coastal Infrastructure Business Unit  
Marine House, 1 Essex Street, Fremantle WA  
PO Box 402 Fremantle, Western Australia 6959

Review	Issue Description	Author	Reviewed By	Date
A	Draft	SB		May 09
0	Final Draft	SB	KI, CB, LR, FL	16 June 09
1	Final	SB	DEC	16 Dec 09

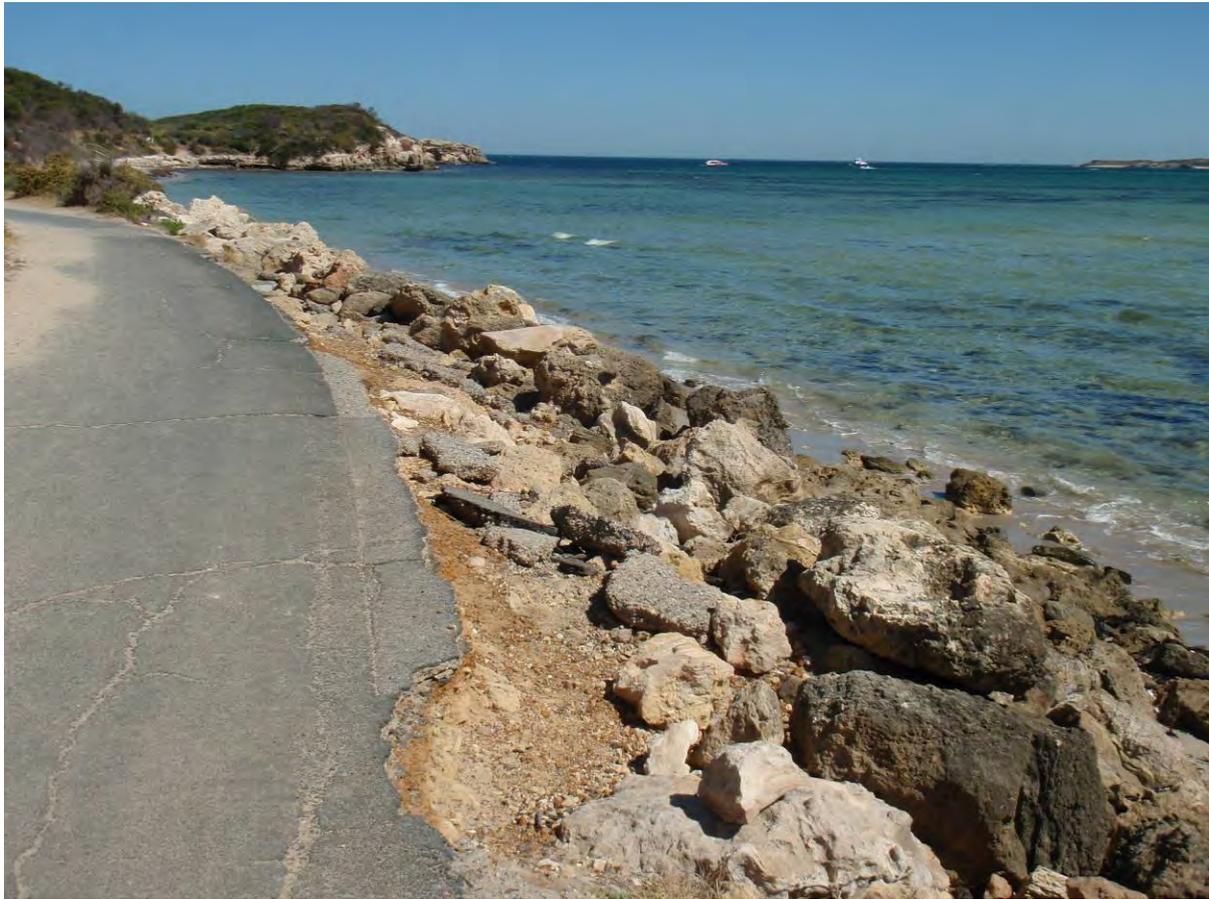
A seawall was constructed in the late 1980's along the coast adjacent to the dual-use path (Figure 2). Its purpose was to provide protection to the path from wave action. It is likely that the seawall was not formally designed and limestone rocks were simply deposited along the path's edge. The seawall is

currently in poor condition with large gaps and there are cracks and breakages along the path's edge (Figure 3).

**Figure 3:** The seawall alongside the dual-use path (27/2/2009)

The seawall that protects the dual-use path is currently in poor condition and if it is not maintained or upgraded, then it will eventually collapse due to erosion of the beach surrounding its structure.

It is likely the seawall was not a formally designed structure, instead rocks were simply deposited along the edge of the path to help protect it. The seawall's current condition is poor and therefore an engineered seawall would have a greater influence in protecting the dual-use path from further erosion. Reconstruction of the seawall will require new rock and use of existing rock to provide sufficient protection along the path. It is likely that a small section of beach on the eastern side of the seawall will experience accelerated erosion caused by waves reflecting off the seawall. Depending on the width of the seawall, sand might initially accumulate on the western side of the seawall and may exaggerate erosion on the other side. Ongoing maintenance of the structure will be required. The seawall will need to be redesigned by a suitably qualified coastal engineer.

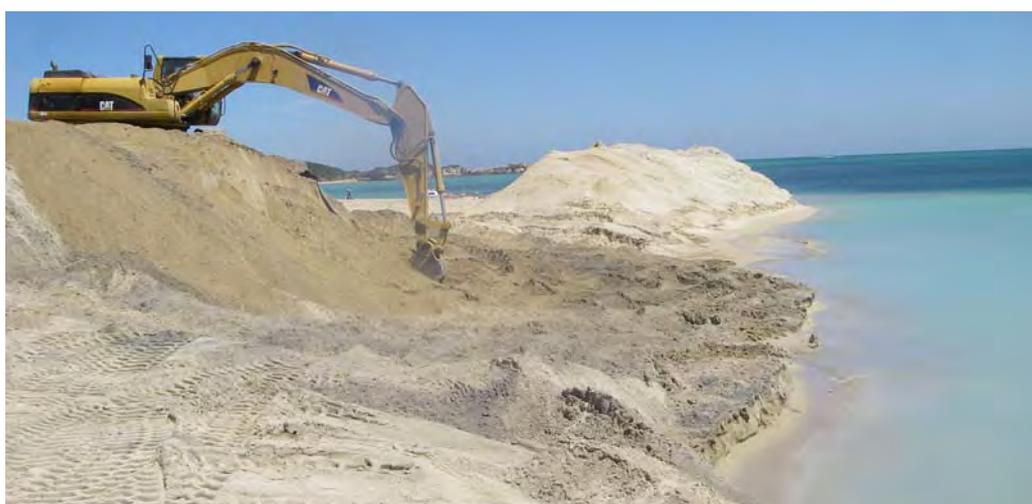
Sand has been excavated from the sand trap since the early 1990's (Figure 4). Removal of sand did not originally occur on an annual basis. Over the last 8 years, however the sand trap has been excavated annually. This has normally been conducted in two separate extractions typically during April to May and September to October. Between 2006 and 2008, approximately 10,000 cubic metres (m<sup>3</sup>) have been removed each year. The removed sand is stockpiled near the site and then trucked to Rockingham, Kwinana and Warnbro Sound beaches, depending on renourishment requirements. Actual volumes of sand have not been recorded, however Table 2 shows the approximate sand volumes removed since 2000.

**Figure 4:** Sand trap at Point Peron during excavation works in November, 2007

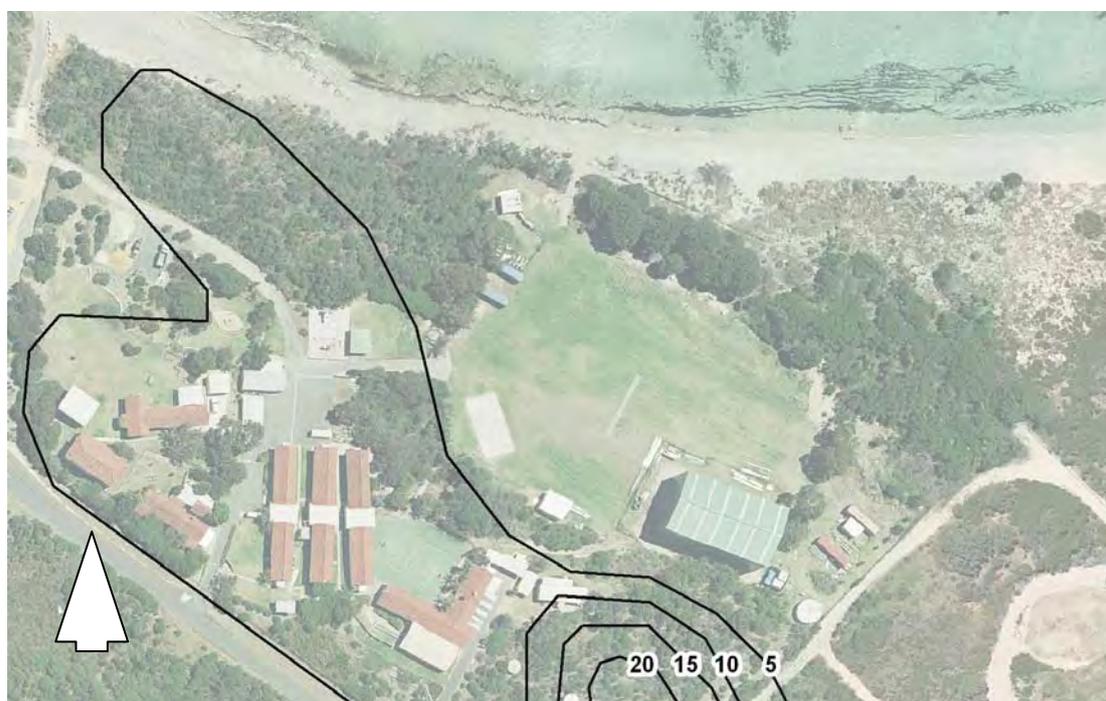
The entire camp school is below 5 mAHD (Figure 12). A brief field survey was conducted of the oval in May 2009, indicating that the approximate average height of the oval is 1.3 mAHD. The implication of these results is that during a reasonably energetic storm (likely to occur approximately once per year) water levels will reach 0.9 mAHD (estimated storm mean water level) which are likely to erode the dune buffer, but unlikely to inundate the oval. The runup height of individual waves during a storm event (2.9 mAHD), however, is likely to cause inundation of the seaward edge of the oval and further accelerate erosion.

Figure 12: Contours around Point Peron camp school and oval (elevation in metres above AHD) Source: DoT (Spatial Information section)

Over the last decade the study area has experienced on average, 2.5 metres of erosion per year. The oval is currently approximately 25 metres away from the vegetation line and is less than five metres above AHD (Figure 12). If the recent erosion rate continues, then the oval could be subject to erosion in 10 years. During energetic storm events elevated water levels may cause the oval to inundate sooner. The mean storm water level is estimated to be approximately 0.9 mAHD. Under these conditions, significant erosion of the dune buffer is expected. The runup height of individual waves during a storm event (2.9 mAHD) is likely to cause inundation of the seaward edge of the oval and further accelerate erosion.

Erosion along the western side of the study area is likely to continue as the shoreline is still adjusting to the Causeway. A controlled retreat along the western side would allow erosion to continue until the shoreline reaches a stable form. This process of shoreline stability will most likely involve the partial loss of the dual-use path and dune in front of the camp school. Therefore the dual-use path would need to be relocated, however due to the nature of the terrain, large earthworks and vegetation removal will be required. Closure of the dual-use path will prevent access to a popular tourist and fire access area. Due to recent years of seawater inundation, the oval's size may need to be reduced to increase its distance from the beach.

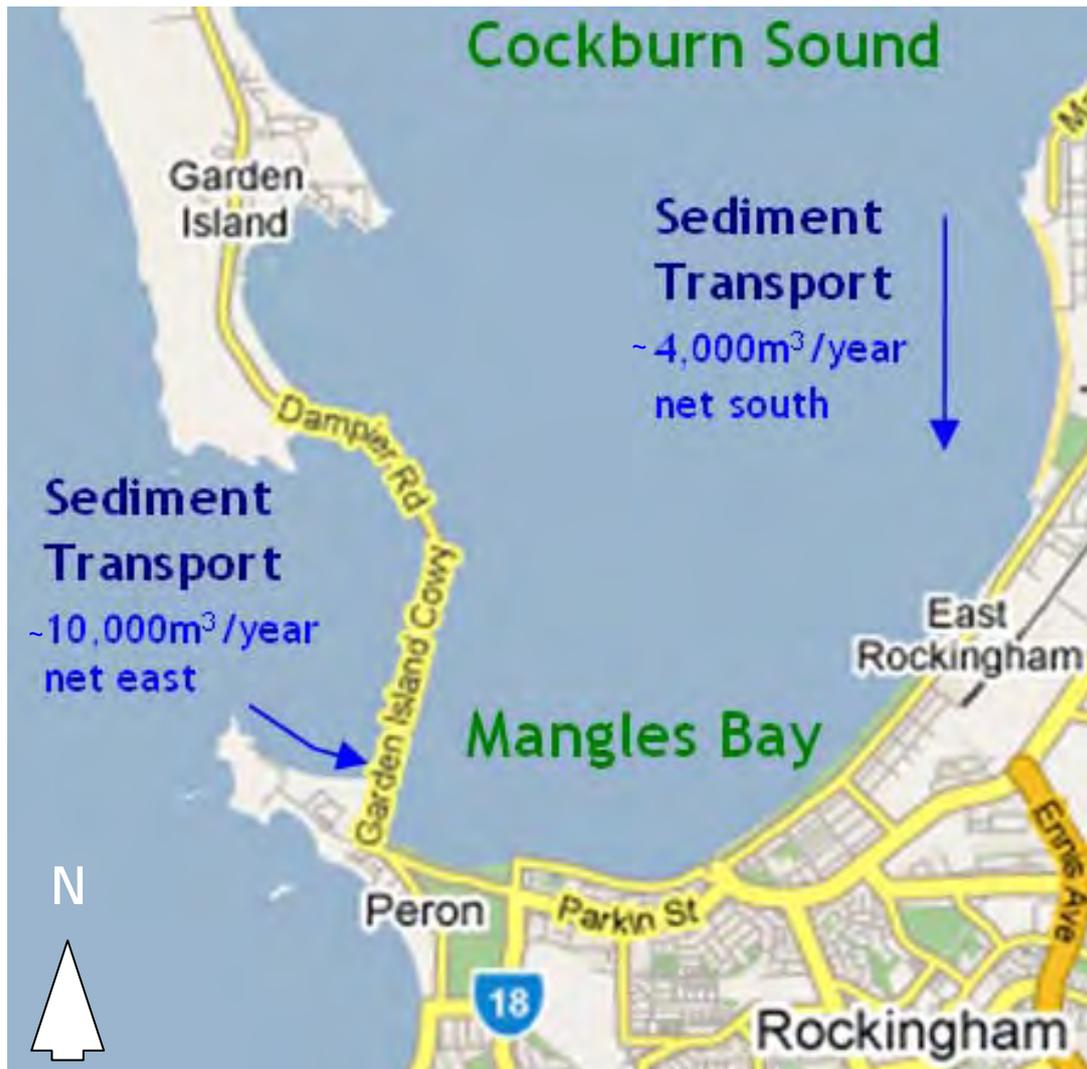
Sediment is transported east along the coast in the study area. This is likely due to swell waves from the south west which arrive throughout the year and wrap around the cape (Figures 8 & 10). South-south westerly summer sea waves and winter storm waves are also likely to wrap around the cape. The Causeway blocks any waves from the east and therefore inhibits sediment moving to the west.

Figure 13: Sediment transport in the study area and Cockburn Sound. NB: Rates are approximate (source: Google maps)

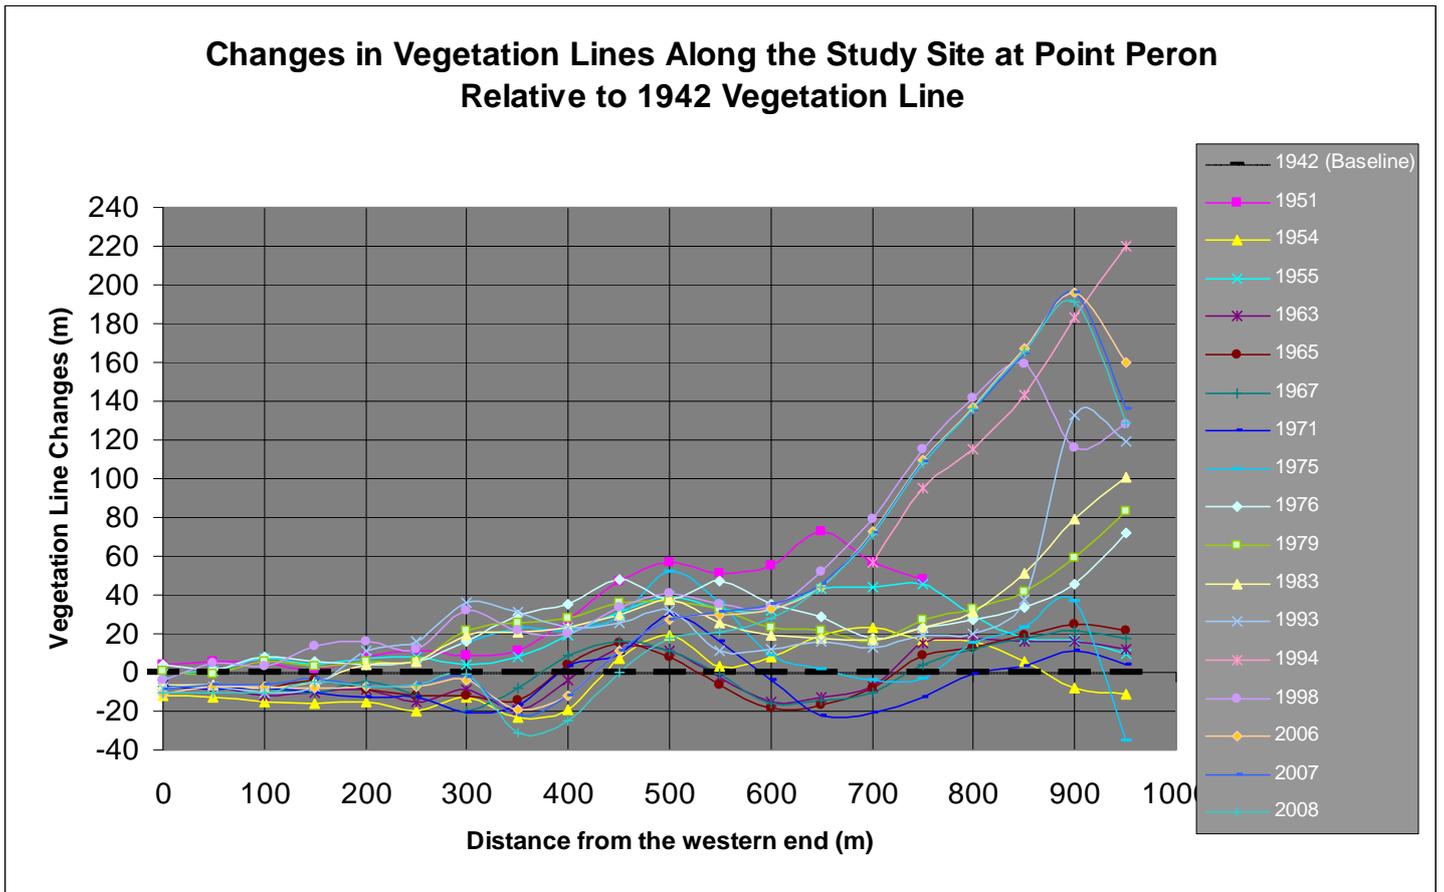
The study area was divided into two sections, a western (chainage 0 - 400m) and an eastern side (chainage 450 - 950m) due to the different changes that have occurred in each over the 66 year period. Figure 20 displays a graph of the average changes for both sides. Average changes for each year were calculated by averaging the distance between the 1942 vegetation line and the year of interest for each of the 50 m cross-section lines. The Garden Island Causeway (1971-1973) appears to have had an impact on both the western (0-400 m) and eastern (450-950 m) sections of the shoreline. Prior to the Causeway, 4 years recorded between 1963 and 1971 showed signs of a dynamically stable shoreline on both sides (eastern and western). Both sides began to accrete after the causeway was built. The 4 year period between 1971 and 1975 saw an accumulation of approximately 31 and 14 metres for the western and eastern locations respectively. From 1975 onwards, the western side has been generally eroding whilst the eastern side has been steadily accumulating, with 45 m accretion from 1993 to 1998. Between 1998 and 2008, the beach in the western section (0 - 400 m) has retreated approximately 25 metres.

Figure 17: Changes in vegetation lines along the study area (from west to east) over a 66 year period for profiles 50 m apart

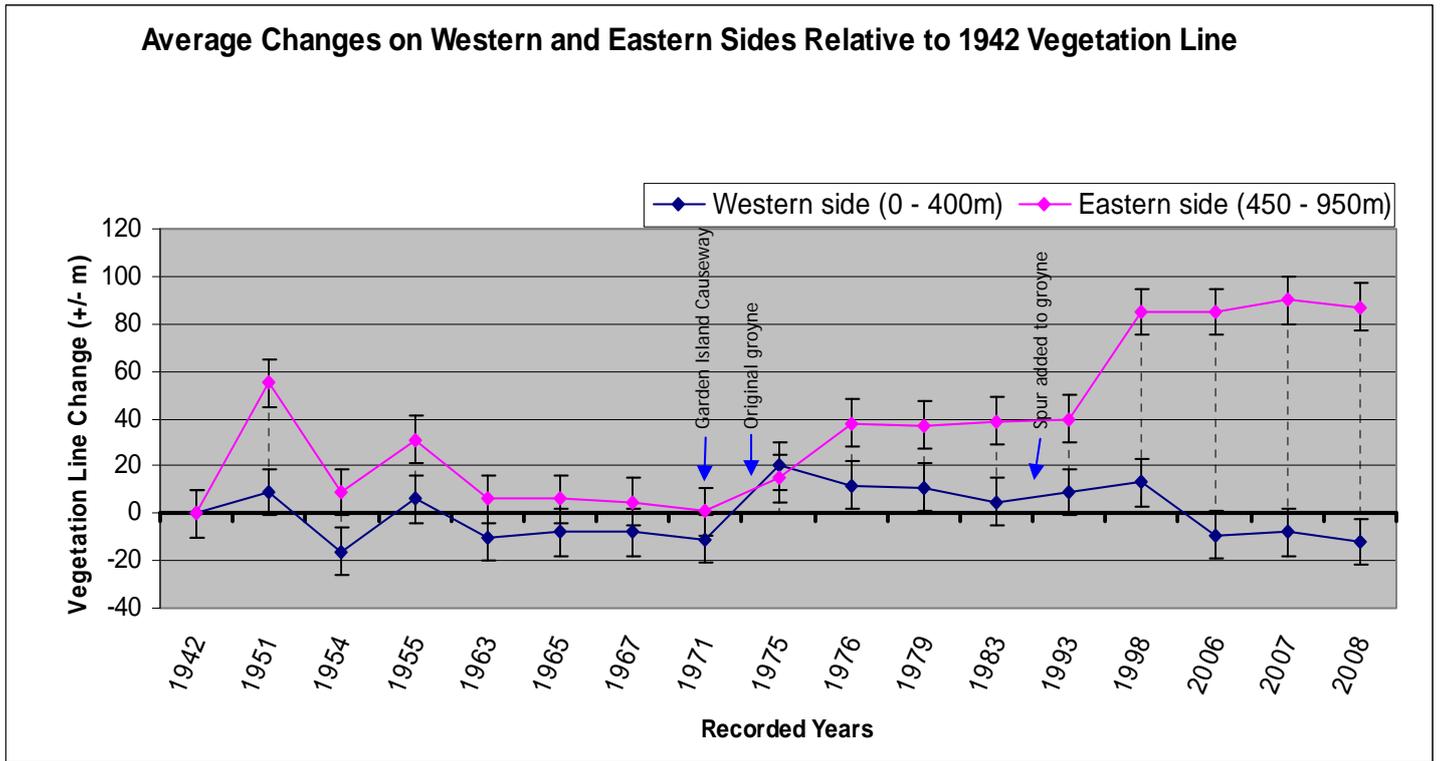
Figure 20: Average changes on each side of the study area (western and eastern) during the 66 year period (Estimated error is  $\pm 10$  m)

The Causeway has impacted greatly on the sediment transport throughout Cockburn Sound. The impacts of the Causeway can be clearly seen in Figure 20 (average changes). The Causeway was constructed between 1971 and 1973 and during this time the shoreline in the western half of the study area began to change.

Vegetation lines for the 17 recorded years were plotted against the 1942 vegetation line. From this information, years of accretion and erosion can be tracked. Between 1971 and 1975, there was found to be an accretion of 31 metres on the western side and 14 metres on the eastern side of the study area. The recorded years from 1975 onwards show that the eastern section has been steadily accreting, especially between 1993 and 1998 (45 m). The western side has generally been eroding since 1975 onwards with the most erosion occurring between 1998 and 2008 (25 m).

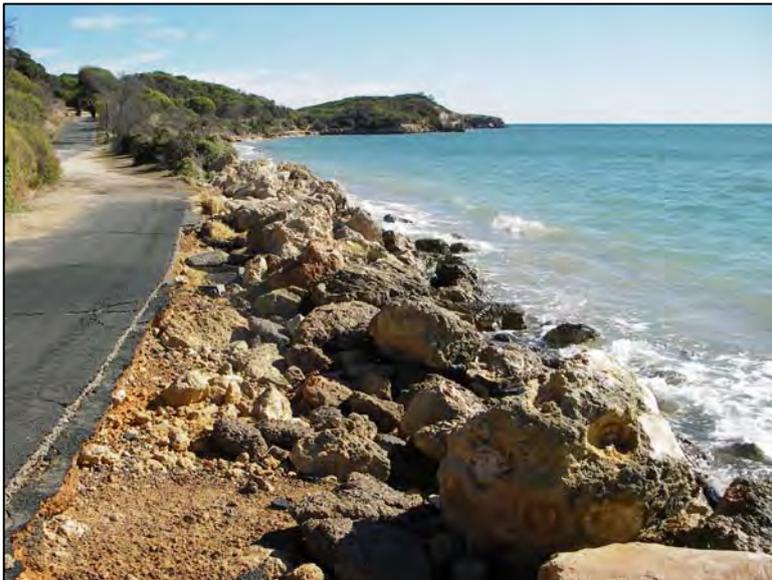
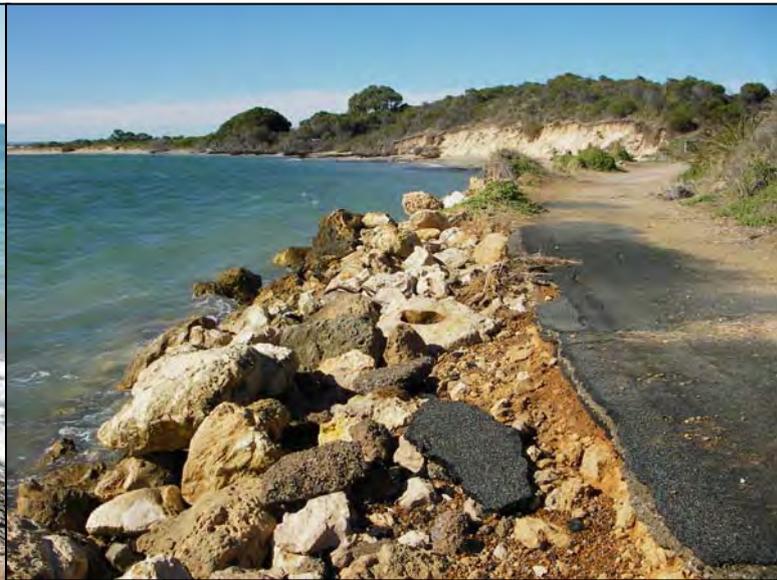
These photographs were captured near the bend in the dual-use path and seawall. Photograph 5 is taken facing back towards the west. Photograph 6 is taken facing towards the dune in front of the camp school. These photographs display the seawall and path's condition.
