# Shoreline Movement Study, Point Peron Rockingham

Department of Transport  
New Coastal Assets Directorate  
Coastal Infrastructure Business Unit  
Marine House, 1 Essex Street, Fremantle WA  
PO Box 402 Fremantle, Western Australia 6959

Review	Issue Description	Author	Reviewed By	Date
A	Draft	SB		May 09
0	Final Draft	SB	KI, CB, LR, FL	16 June 09
1	Final	SB	DEC	16 Dec 09

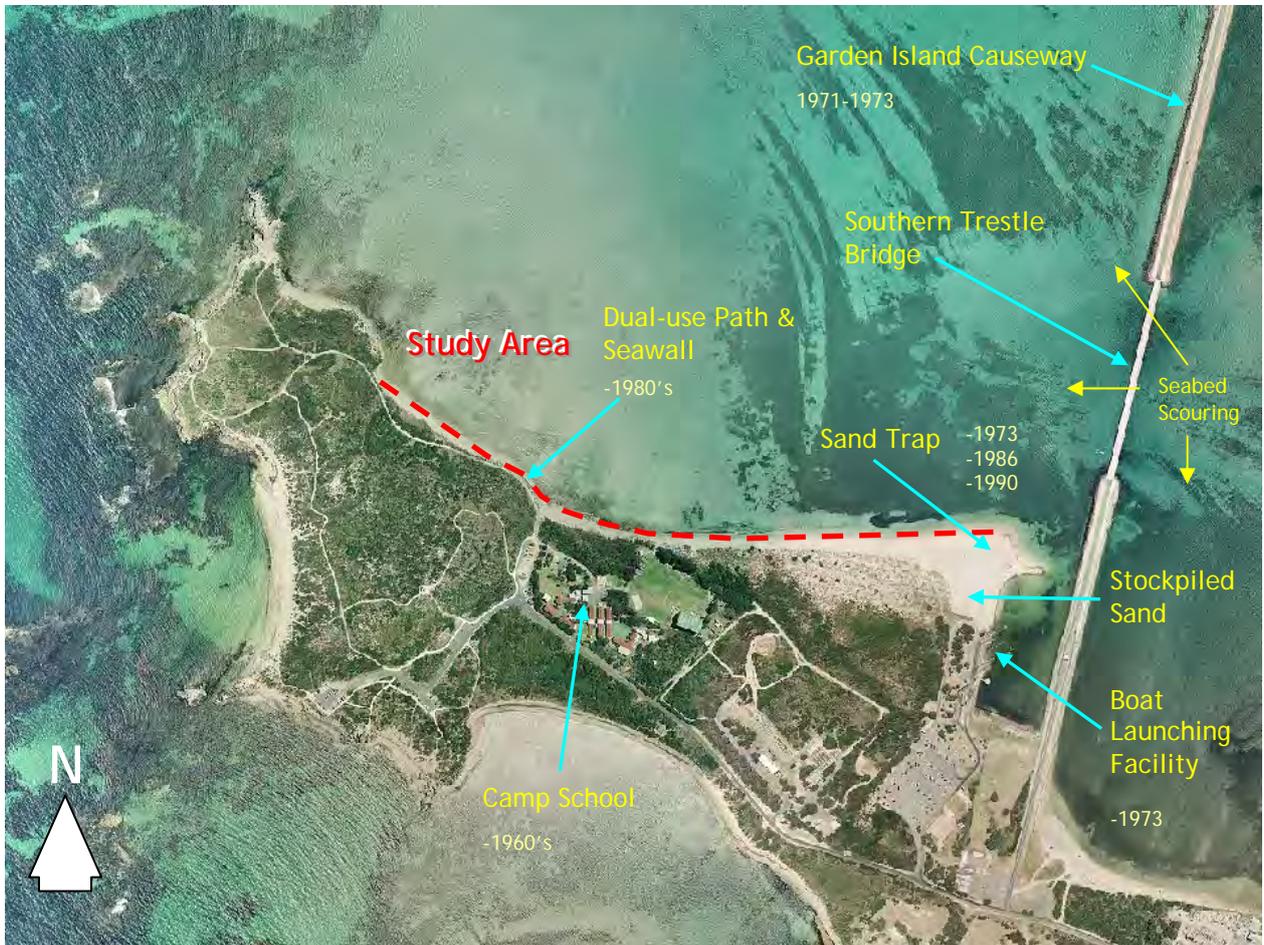
Figure 2: Features of Point Peron including construction dates (2009 image)

A seawall was constructed in the late 1980's along the coast adjacent to the dual-use path (Figure 2). Its purpose was to provide protection to the path from wave action. It is likely that the seawall was not formally designed and limestone rocks were simply deposited along the path's edge. The seawall is

currently in poor condition with large gaps and there are cracks and breakages along the path's edge (Figure 3).

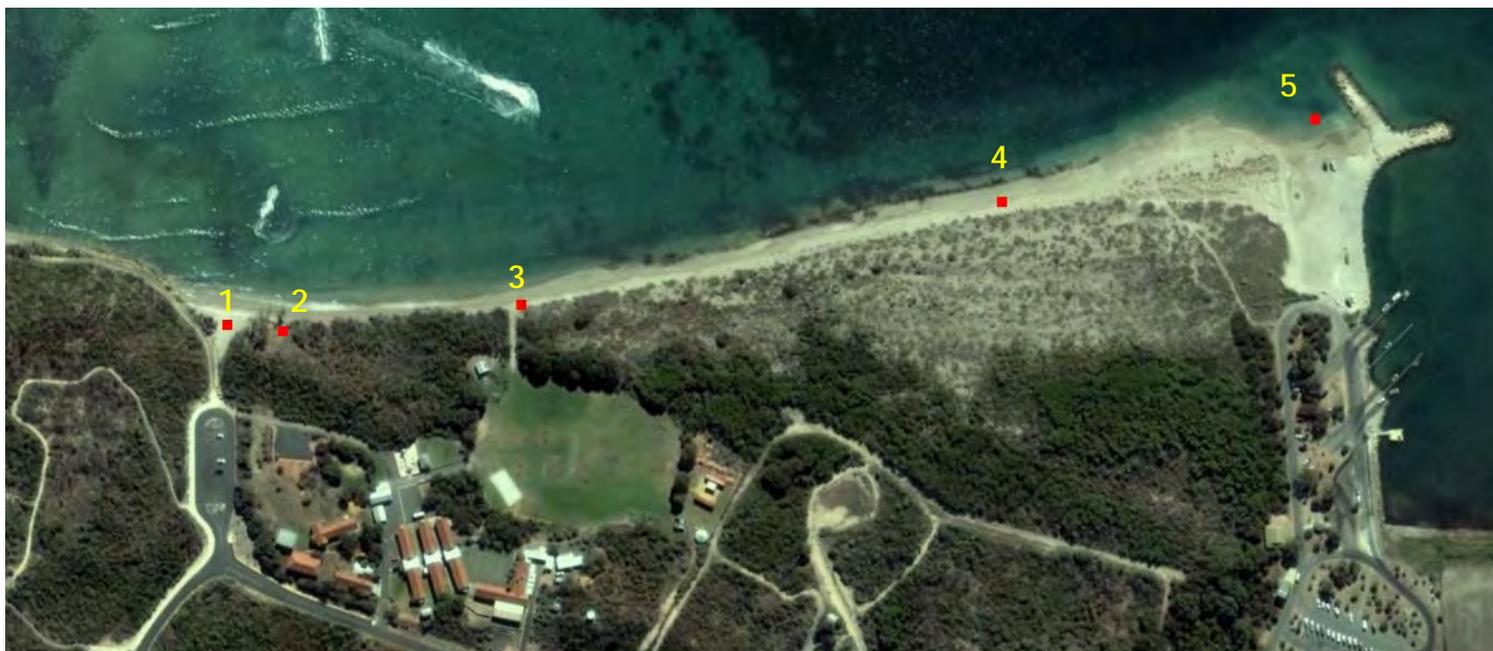
Figure 14: Location of sand samples collected

On the 27<sup>th</sup> of February 2009, six sand samples were collected from along the study site (Figure 14). Sand was collected 15 cm below the beach surface within the intertidal zone. These samples were then analysed under a microscope and the contents were examined. Table 5 summarises the contents of each sand sample, location collected and the approximate percentages of biogenic (e.g. mollusc shells, sponge spicules) and non-biogenic (e.g. quartz). The majority of each sand sample contained non-biogenic material such as quartz, feldspar and limestone. Appendix 4 displays a photograph of each sand sample taken under a microscope at 10 X magnification.

The contents of the sand samples suggest that the sources of sediments are from the offshore submarine limestone reef that extends from the south of Point Peron northwards. The sediments are pale yellow and brown quartz with traces of feldspar. There is a small amount of calcium carbonate from shell debris (Appendix 4).

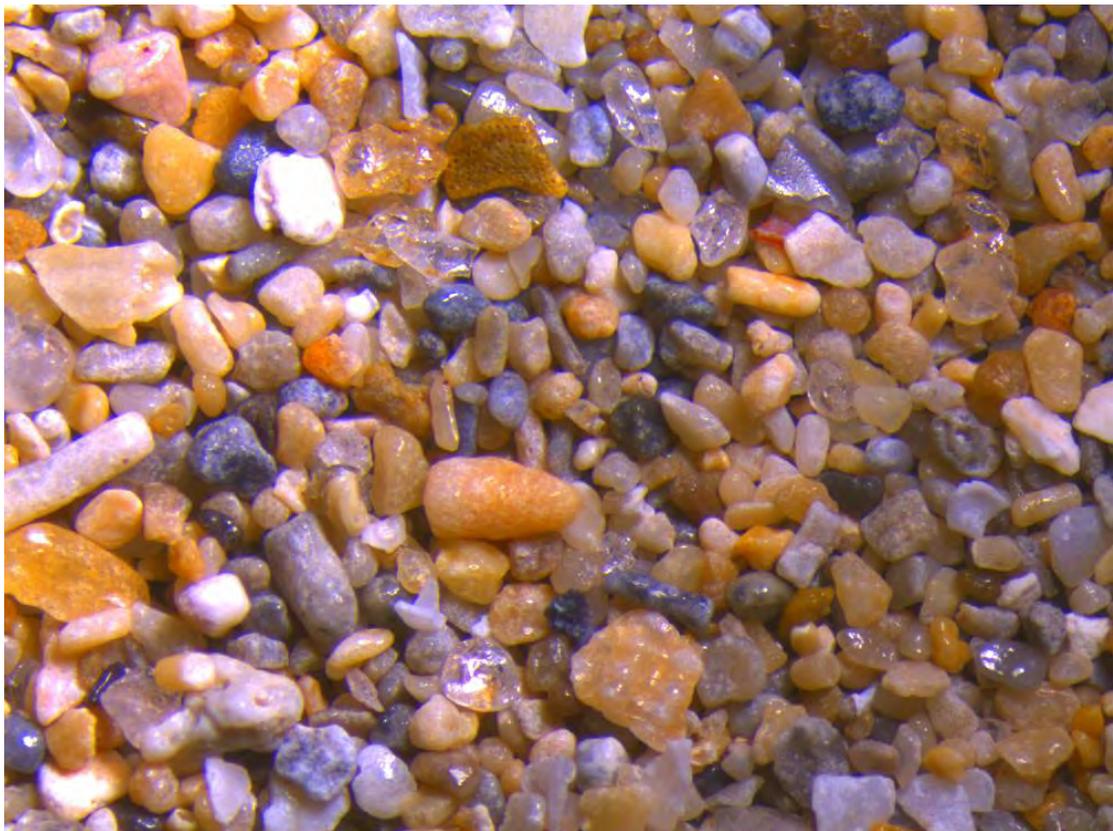
Figure 15: The contents of sand sample 4

Sample	Location	Biogenic %	Non- Biogenic %
1	Near dual-use path	<5%	>95%
2	Dune east of path	~30%	~70%
3	In front of oval path	~10%	~90%
4	West of sand trap	~10%	~90%
5	Sand trap (before excavation)	~5%	~95%
6	Hymus Street (east of Causeway)	~25%	~75%

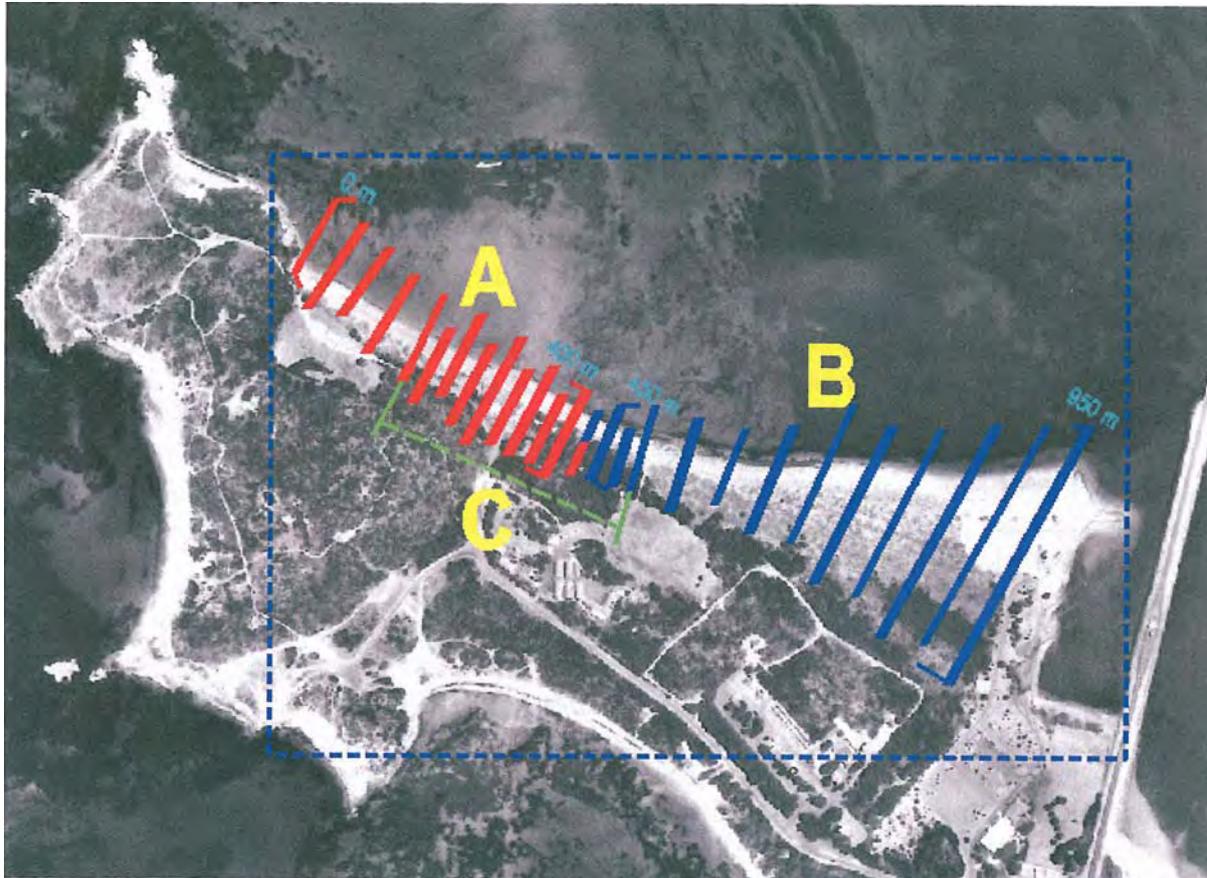
**Figure 16:** The study area at Point Peron (A: Western side; B: Eastern side; C: Dual-use path to oval) - 1998 photograph

The study area was divided into two sections, a western (chainage 0 - 400m) and an eastern side (chainage 450 - 950m) due to the different changes that have occurred in each over the 66 year period. Figure 20 displays a graph of the average changes for both sides. Average changes for each year were calculated by averaging the distance between the 1942 vegetation line and the year of interest for each of the 50 m cross-section lines. The Garden Island Causeway (1971-1973) appears to have had an impact on both the western (0-400 m) and eastern (450-950 m) sections of the shoreline. Prior to the Causeway, 4 years recorded between 1963 and 1971 showed signs of a dynamically stable shoreline on both sides (eastern and western). Both sides began to accrete after the causeway was built. The 4 year period between 1971 and 1975 saw an accumulation of approximately 31 and 14 metres for the western and eastern locations respectively. From 1975 onwards, the western side has been generally eroding whilst the eastern side has been steadily accumulating, with 45 m accretion from 1993 to 1998. Between 1998 and 2008, the beach in the western section (0 - 400 m) has retreated approximately 25 metres.

The shoreline along the study section is likely to still be adjusting to the presence of the Garden Island Causeway. Before the Causeway, there was wave action from the west and the east. Since the Causeway's construction, waves from the east have been limited. Waves from the west are now the sole driver of longshore sediment transport. The original sand trap groyne that was constructed during the same period as the Causeway, provided shelter for the boat launching facility from sedimentation. Sand accumulated on its western side until the groyne was "saturated". Between 1986 and 1990, 2 extensions were constructed. The structure was again saturated with sediment, hence annual excavation works at the sand trap.

However, the western side is still adjusting and this involves realigning with the shoreline on the eastern side. This process of realignment is likely to be a significant driver of the erosion in the western half of the study area.

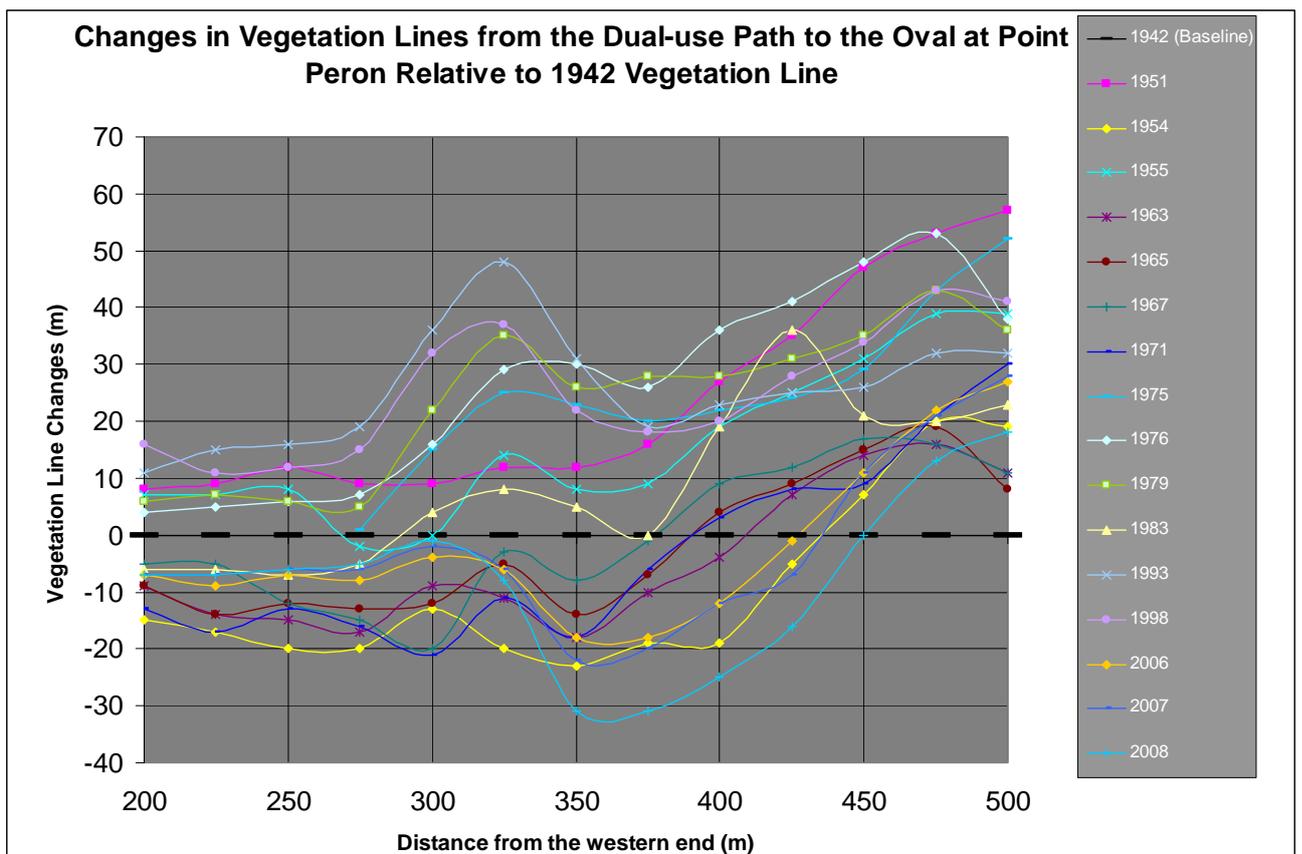
Figure 19: Changes in vegetation lines between the dual-use path and the oval over a 66 year period for profiles 25 m apart

Vegetation lines for the 17 recorded years were plotted against the 1942 vegetation line. From this information, years of accretion and erosion can be tracked. Between 1971 and 1975, there was found to be an accretion of 31 metres on the western side and 14 metres on the eastern side of the study area. The recorded years from 1975 onwards show that the eastern section has been steadily accreting, especially between 1993 and 1998 (45 m). The western side has generally been eroding since 1975 onwards with the most erosion occurring between 1998 and 2008 (25 m).

Over the last decade the study area has experienced on average, 2.5 metres of erosion per year. The oval is currently approximately 25 metres away from the vegetation line and is less than five metres above AHD (Figure 12). If the recent erosion rate continues, then the oval could be subject to erosion in 10 years. During energetic storm events elevated water levels may cause the oval to inundate sooner. The mean storm water level is estimated to be approximately 0.9 mAHD. Under these conditions, significant erosion of the dune buffer is expected. The runup height of individual waves during a storm event (2.9 mAHD) is likely to cause inundation of the seaward edge of the oval and further accelerate erosion.

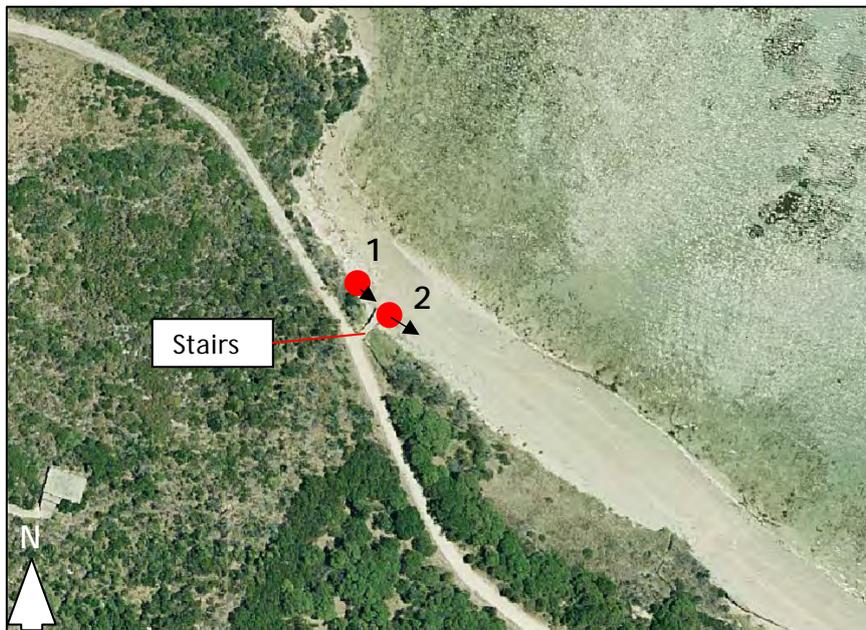
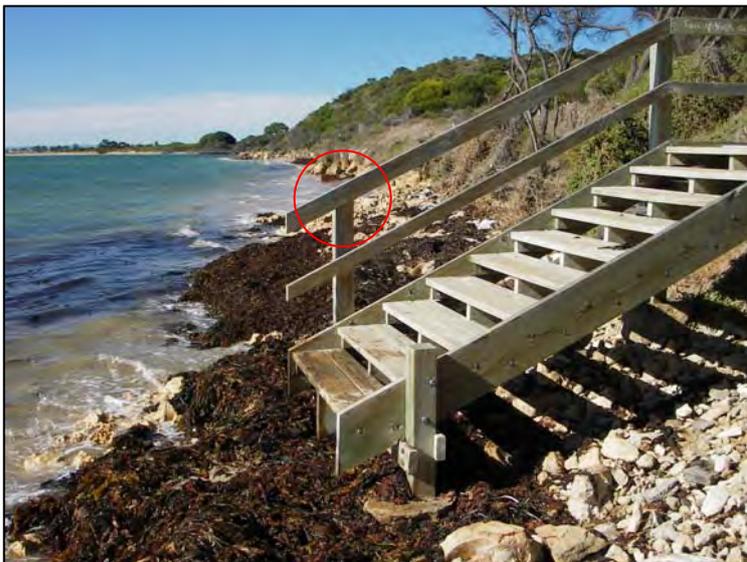
These photographs are captured from the western end of the study area near the stair access to the beach. Photograph 1 compares the beach height and water level with the end of the stairs (facing towards the seawall). Photograph 2 is taken from the bottom post of the stairs (facing towards the seawall).

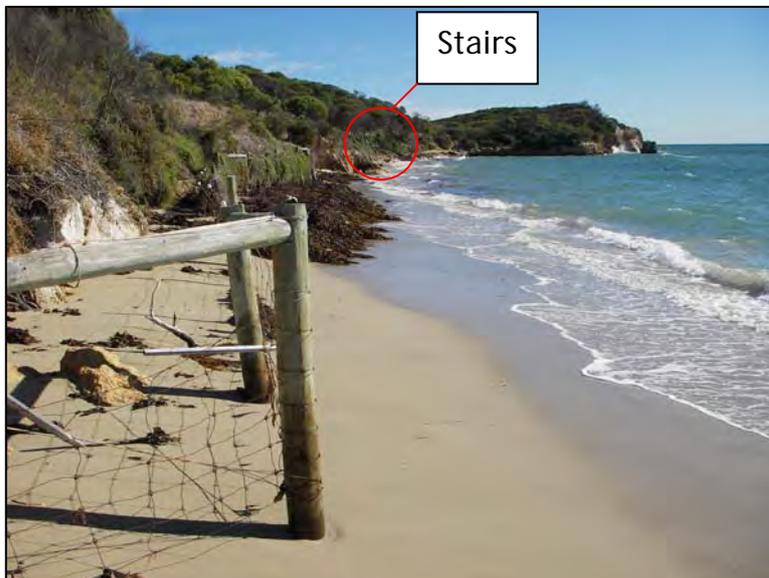
The following photographs are captured from the corner of a fence that runs along the edge of the vegetation line. The corner of the fence is about 25 m from two concrete tubes that are on either side of the path. Photograph 3 is taken facing back towards the stairs. Photograph 4 is taken facing towards the seawall.

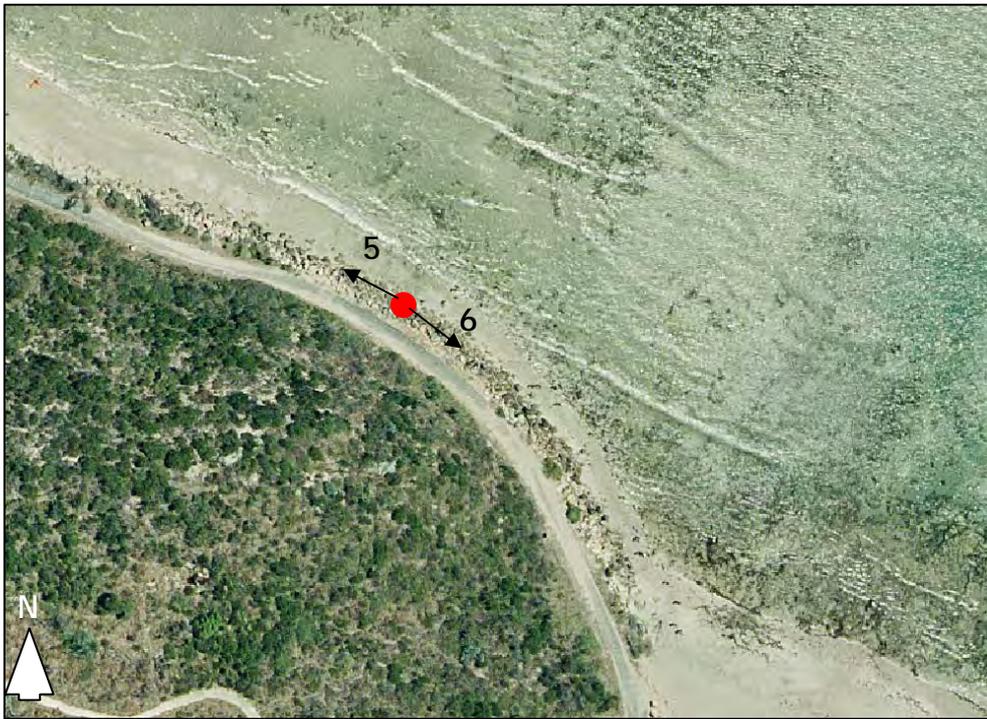
These photographs were captured near the bend in the dual-use path and seawall. Photograph 5 is taken facing back towards the west. Photograph 6 is taken facing towards the dune in front of the camp school. These photographs display the seawall and path's condition.

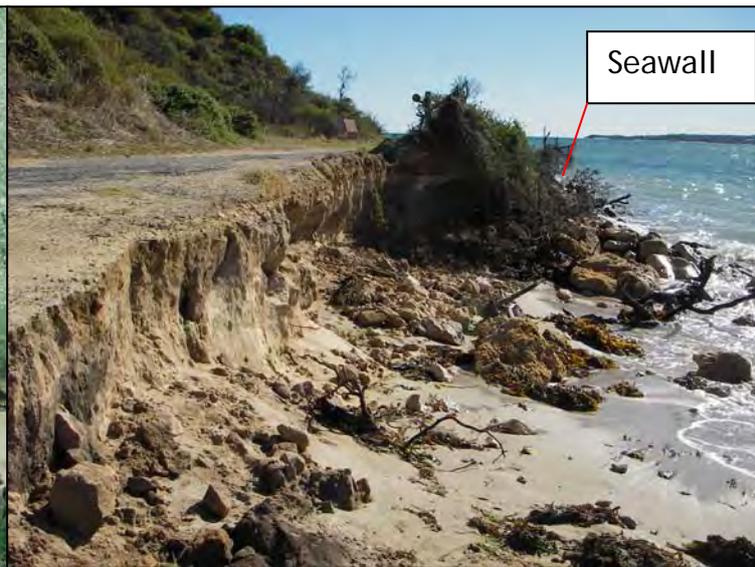
The following photographs are taken from a small eroded section alongside the path and in between the start of the seawall and the dune. Photograph 7 is taken in line with the 'Mangles Bay/Shoalwater Bay' sign, and facing towards the seawall. Photograph 8 is taken from near the start of the seawall towards the corner of the dune. Photograph 9 is taken from the corner of the dune and faces eastwards.

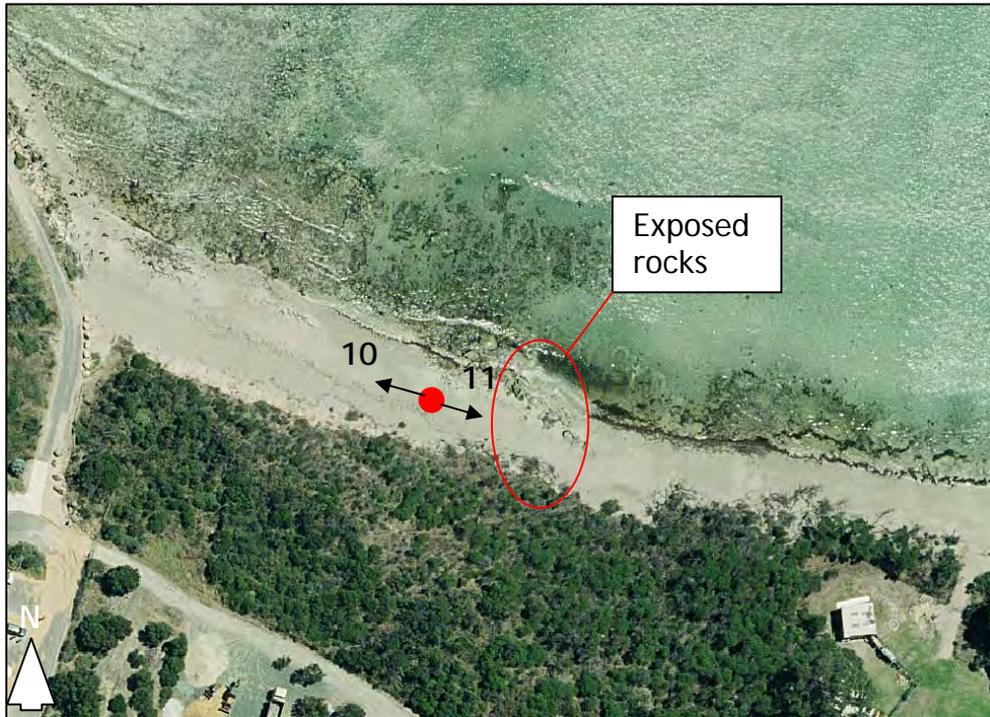
These photographs are taken from where there are exposed rocks along the beach. Photograph 10 is taken from the rocks and faces back towards the seawall. Photograph 11 faces east and taken just before the rocks and a large sand bag.

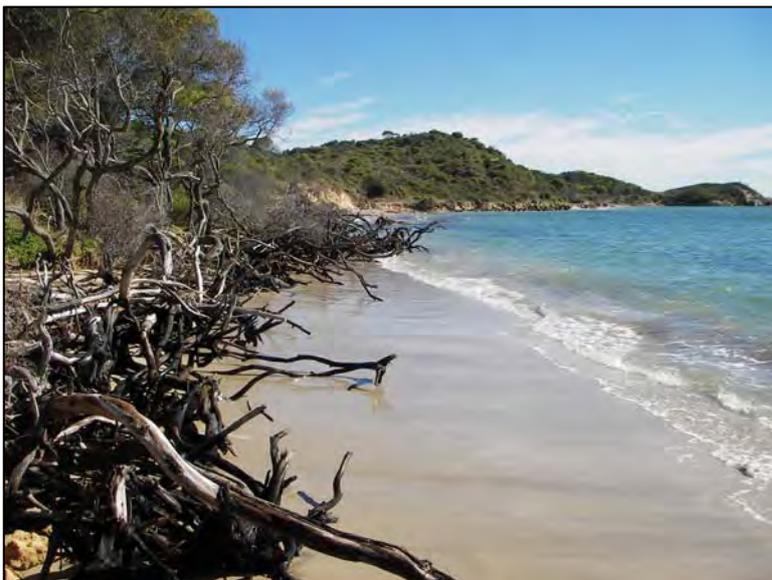
The following photographs are taken from the fence posts at the end of the oval's path to the beach. Photograph 12 is taken standing beside the right post (when facing the oval) and captures the beach towards the exposed rocks. Photograph 13 is taken standing beside the left post and faces eastwards along the beach.

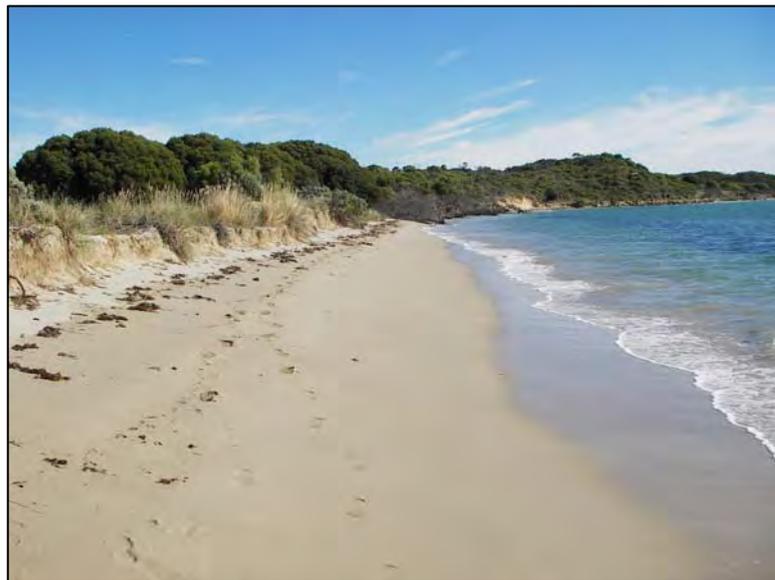
These photographs are taken in front of a large bush that protrudes from the vegetation line. It is approximately 140 m from the end of the oval's path. Photograph 14 shows the beach towards the oval and photograph 15 shows the beach towards the sand trap.

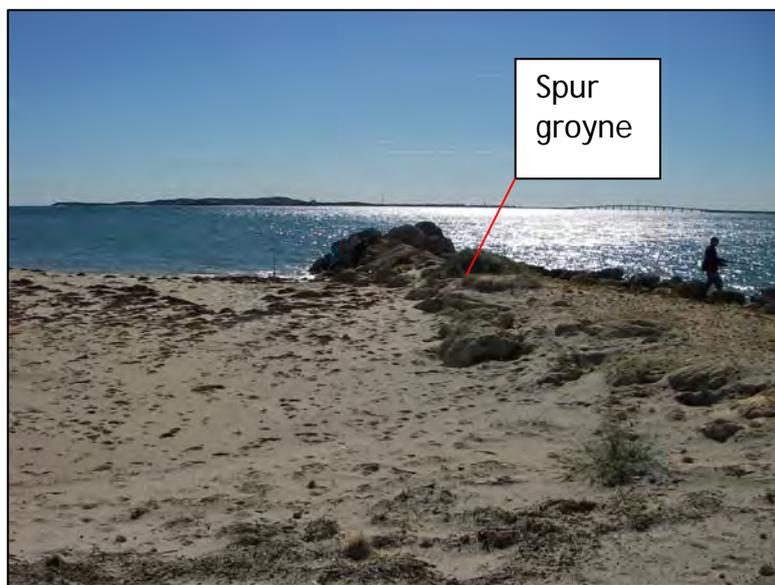
Photograph 16 is taken from the fence post at the start of the spur groyne and faces towards the spur. Photograph 17 is taken near the middle of the spur groyne and faces to the west.
